## Heavy Fire in Lightweight Construction

BY SYDNEY HENRY JR.

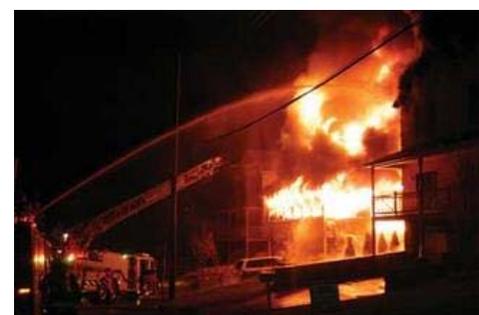
(1) Photos by John Falcone. [Click here to enlarge image](#)

Ladder 55 was first due and was raising its aerial when the trapped resident jumped onto the roof of a police car, which was parked in the driveway. The fire department ambulance subsequently transported him to Westchester Medical Center for treatment of minor injuries. All other residents self-evacuated (photo 1).

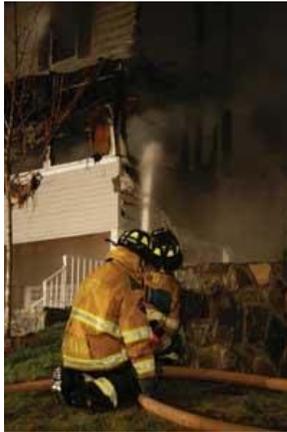
(2)

Ladder 55 then placed its ladder pipe in operation in front of 20 North Mortimer Avenue (the original fire building). In addition, a number of 2½-inch handlines were deployed there (photo 2).

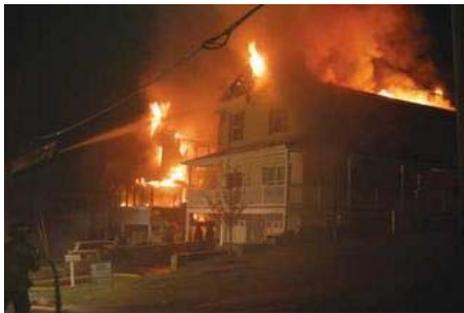
(3)

Before the incident, the fire department was aware that the houses at 18, 20, and 22 North Mortimer Avenue, built in May 2005, all were of wood-frame lightweight construction. Because of the lightweight construction of exposure D and the heavy fire conditions in the attic, no interior operations were initiated. "Lightweight construction: exterior operations only" was announced over the fireground radio.

Shortly after these operations had begun, the entire roof of exposure D collapsed catastrophically (photo 3).

- Immediate request for mutual aid quickly enhanced fireground operations and supplemental water supplies.
- Lightweight construction featuring wood truss/gusset plates and particleboard burns very hot and very fast and collapses early in the operations. Early recognition of this construction and implementing defensive operations are essential for firefighter safety.

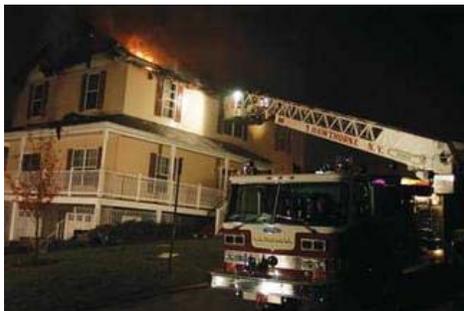
(4)

Tower Ladder 12 raised its bucket to the D side of exposure D, darkening the fire in the roof and taking out all second-floor windows, facilitating access to the fire by the exterior handline streams (photo 4).
